Background:

Manhole Repair on Pittsburgh's Monongahela River

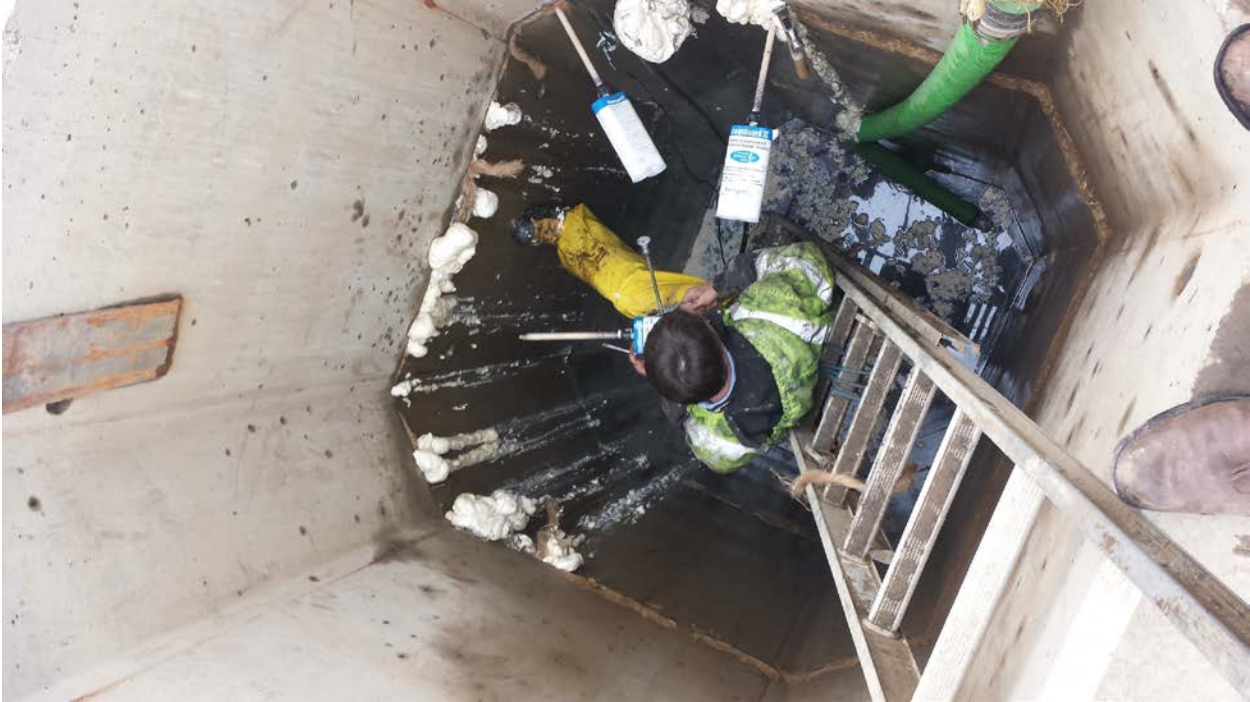
Access to the interior of the manhole was gained after carefully making it across the temporary scaffolding to the center of the river. The water entry point was immediately visible along the impact side of the first precast joint of the manhole, which was about 8 ft below the water line. Static mixers were spaced evenly throughout the joint (about 1 ft apart), and oakum rope was methodically worked into the joint to prevent material washout (preparation is key!). Working from one side of the leak to the other, a continuous grout interface was created through the keyed precast joint; a total of 14 tube sets were used to shut off the inflow. Total time spent in the manhole was under one hour.
