Case Study  
Shaft Grouting / Coal Mine / WVa

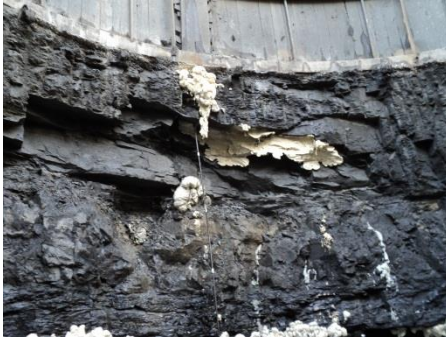
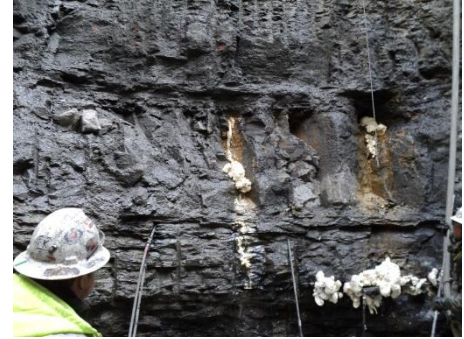
A contractor driving a mine shaft at a coal mine in West Virginia descended through a layer of water bearing broken shale. Prior to the installation of the concrete shaft liner all active water infiltration must be controlled.

Due to the amount and force of the water infiltration we used our multi-purpose single component HyperFlex formulation pumped out of 55 gallon drums with a Graco Bulldog pump. Beginning at the top of the affected area and injecting in a pattern to ensure full coverage, we introduced material until there was a strong show at the face or until the pumping pressure spiked over 5,000 psi.

Our crew quickly solved the water infiltration issues and the shaft work continued to a successful conclusion. Due to the relatively short cure time of HyperFlex, work stoppage was able to be kept to a minimum.
