Water Control-Pre-Cast Cut and Cover Culvert Sections
Power Station- Western Pennsylvania

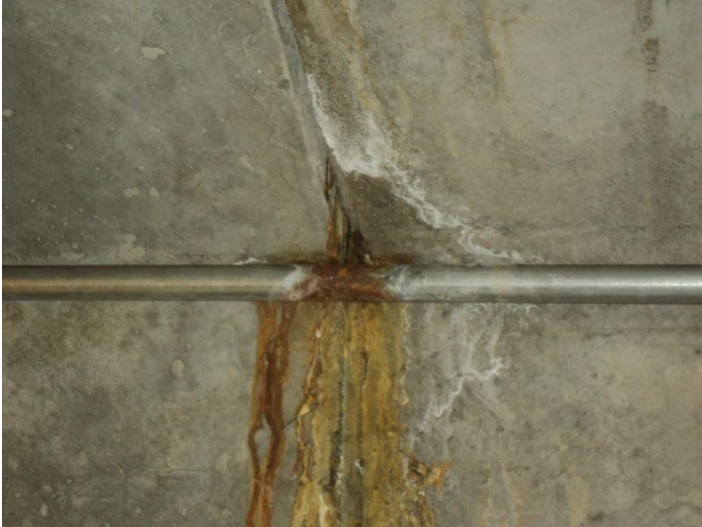
This is an example of the corrosion and rusting of the electrical conduit in the tunnel prior to injection.

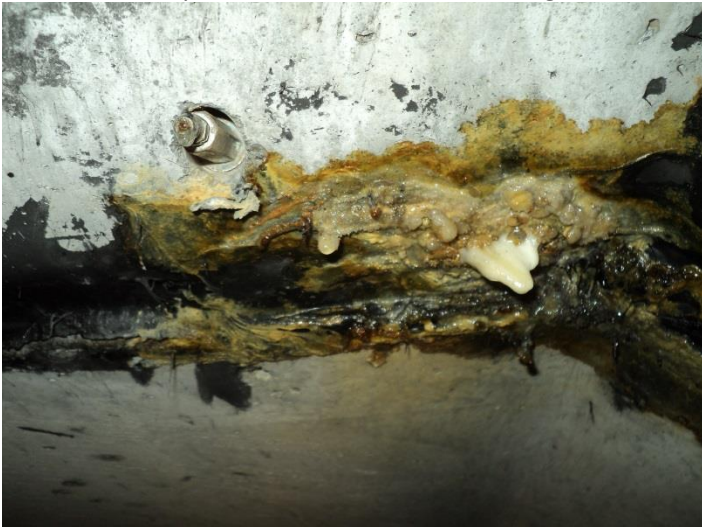
This shows the proper depth to set the packer and also the discoloration & deterioration of the leaking tunnel.

While none of the leaks were particularly large by themselves, the length of the tunnel and the number of leaking joints resulted in quite a volume of water ingress. Due to that fact, we elected to use our Hyperflex material, a single component, pre-catalyzed, hydrophobic grout. Its extended reaction time allows it to flow all through the joint prior to reacting, giving the best possible seal. A converted airless paint sprayer and 5/8 inch injection packers were used to install the Hyperflex. The pre-cast sections were full of rebar, which added to the degree of difficulty in drilling holes to set the packers. Rebar, when hit, will stop a drill cold and many times there is no other choice but to start over and drill again. We intersected the joints about 6 inches or so from the face and injected the joint until a show of material was seen at the face of the joint. The tar strip only filled the first three inches or so of the joint so it served nicely to chink the joint and keep the Hyperflex where it belongs. Given the uniformity of the joint we were injecting it was only necessary to drill three holes in each, one in the ceiling and one each in the two walls.

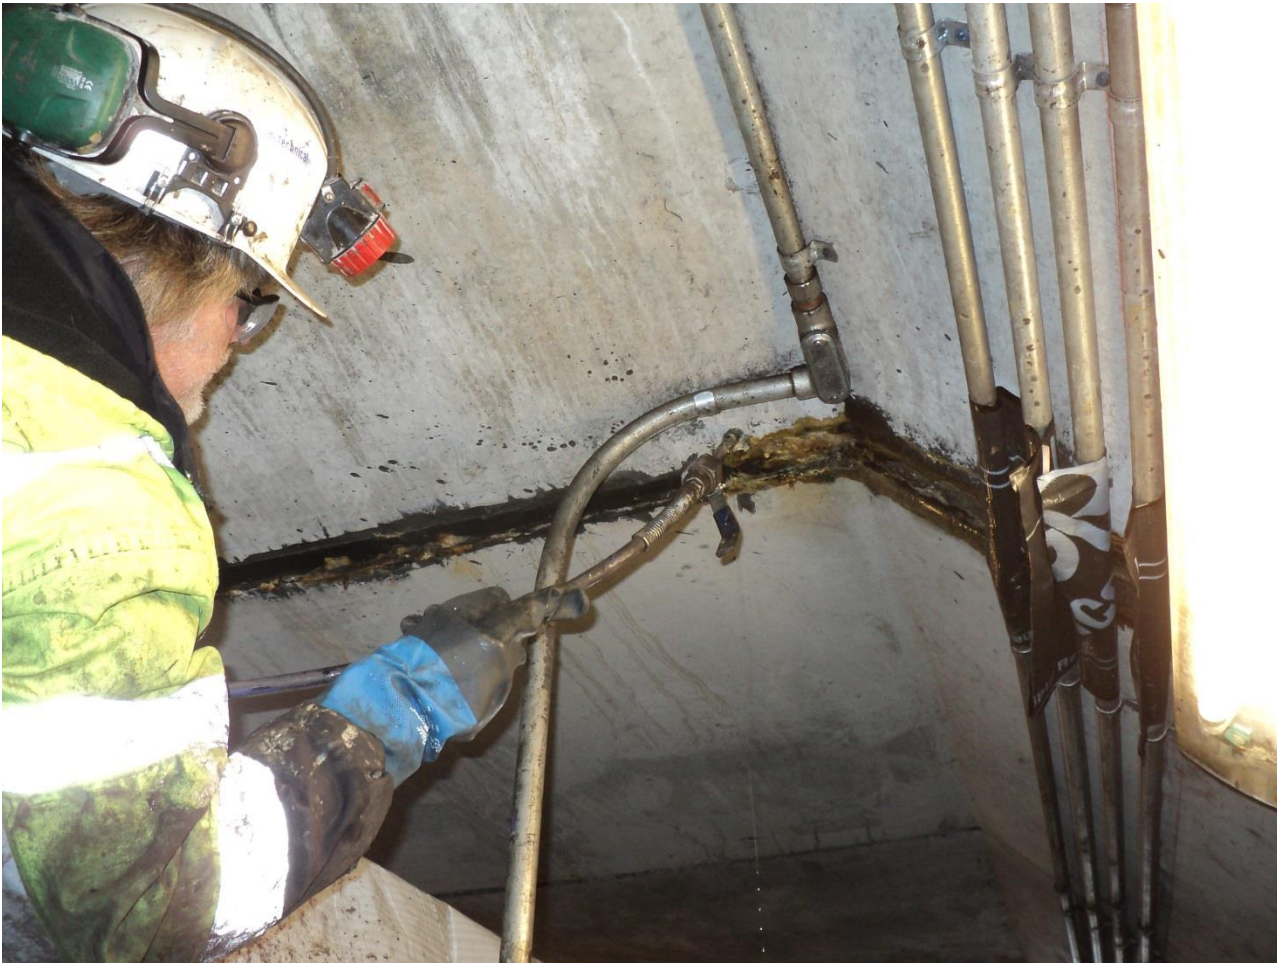
This shows our Sr. project Manager injecting HyperFlex into the joint.

The HyperFlex migrated around the perimeter of the pre-cast joint, expanding and filling it and any voids present out of sight on the other side of the wall. The customer was so happy with the work Sub-Technical did on the leaking joints that we were asked to come back and grout the rest as a preventative measure.
